**Subject: McClanahan Village – Phase 1 Environmental Site Assessment**  
TPN: 11828320203; Mullen Rd SE, Lacey, WA 98503  
Project # QG25-137

# PHASE 1 ENVIRONMENTAL SITE ASSESSMENT

MCCLANAHAN VILLAGE  
PARCEL # 11828320203  
MULLEN RD SE  
LACEY, WA 98503

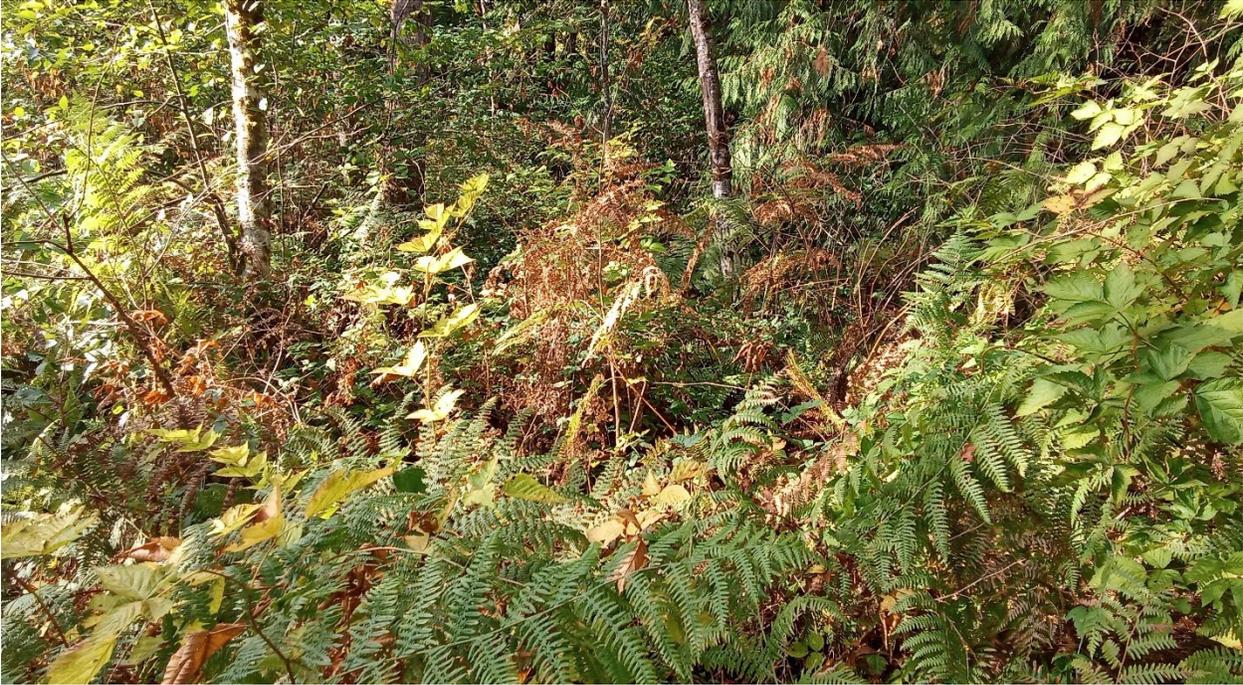
**Photo 1.** General site conditions as viewed from the western portion of the parcel. No signs of leaks or spills on the ground or surrounding equipment on site. Camera facing east into the parcel.

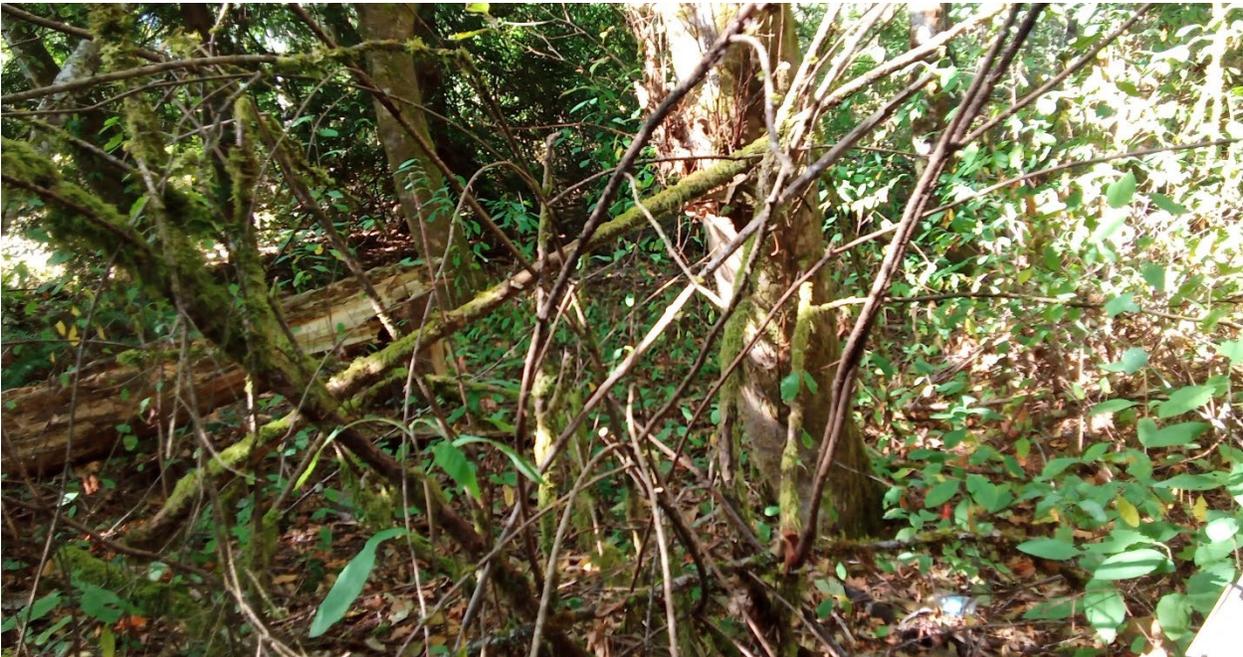
**Photo 2.** General site conditions as viewed from the eastern portion of the parcel. No signs of leaks or spills on the ground or surrounding equipment on site. Camera facing southwest.

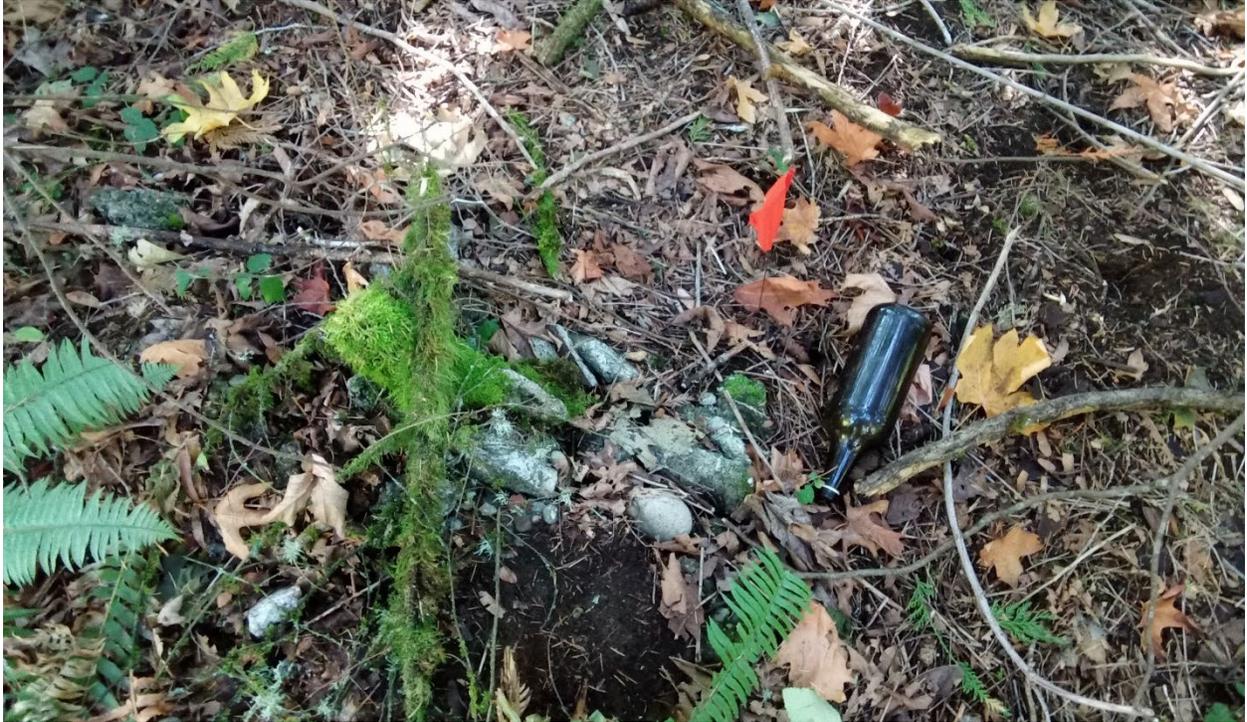
There were no significant stockpiles of debris on site, only scatterings of litter along the edge of the NE parcel boundary were observed. Scattered litter is likely from passing vehicles and pedestrians of Mullen Rd SE. No indications of recent or past disposal of potentially hazardous waste were apparent. There were no pits, ponds, or lagoons on site. No indications of underground storage tanks were observed.

**Photo 3.** Site had occasional litter along Mullen Rd SE; amount of litter was small and does not pose a significant risk to the local environment. Photo facing north.
